Arkansas Department of Environmental Quality

Remedial Action Decision Document

Cedar Chemical Company
West Helena, Phillips County, Arkansas

February 2010

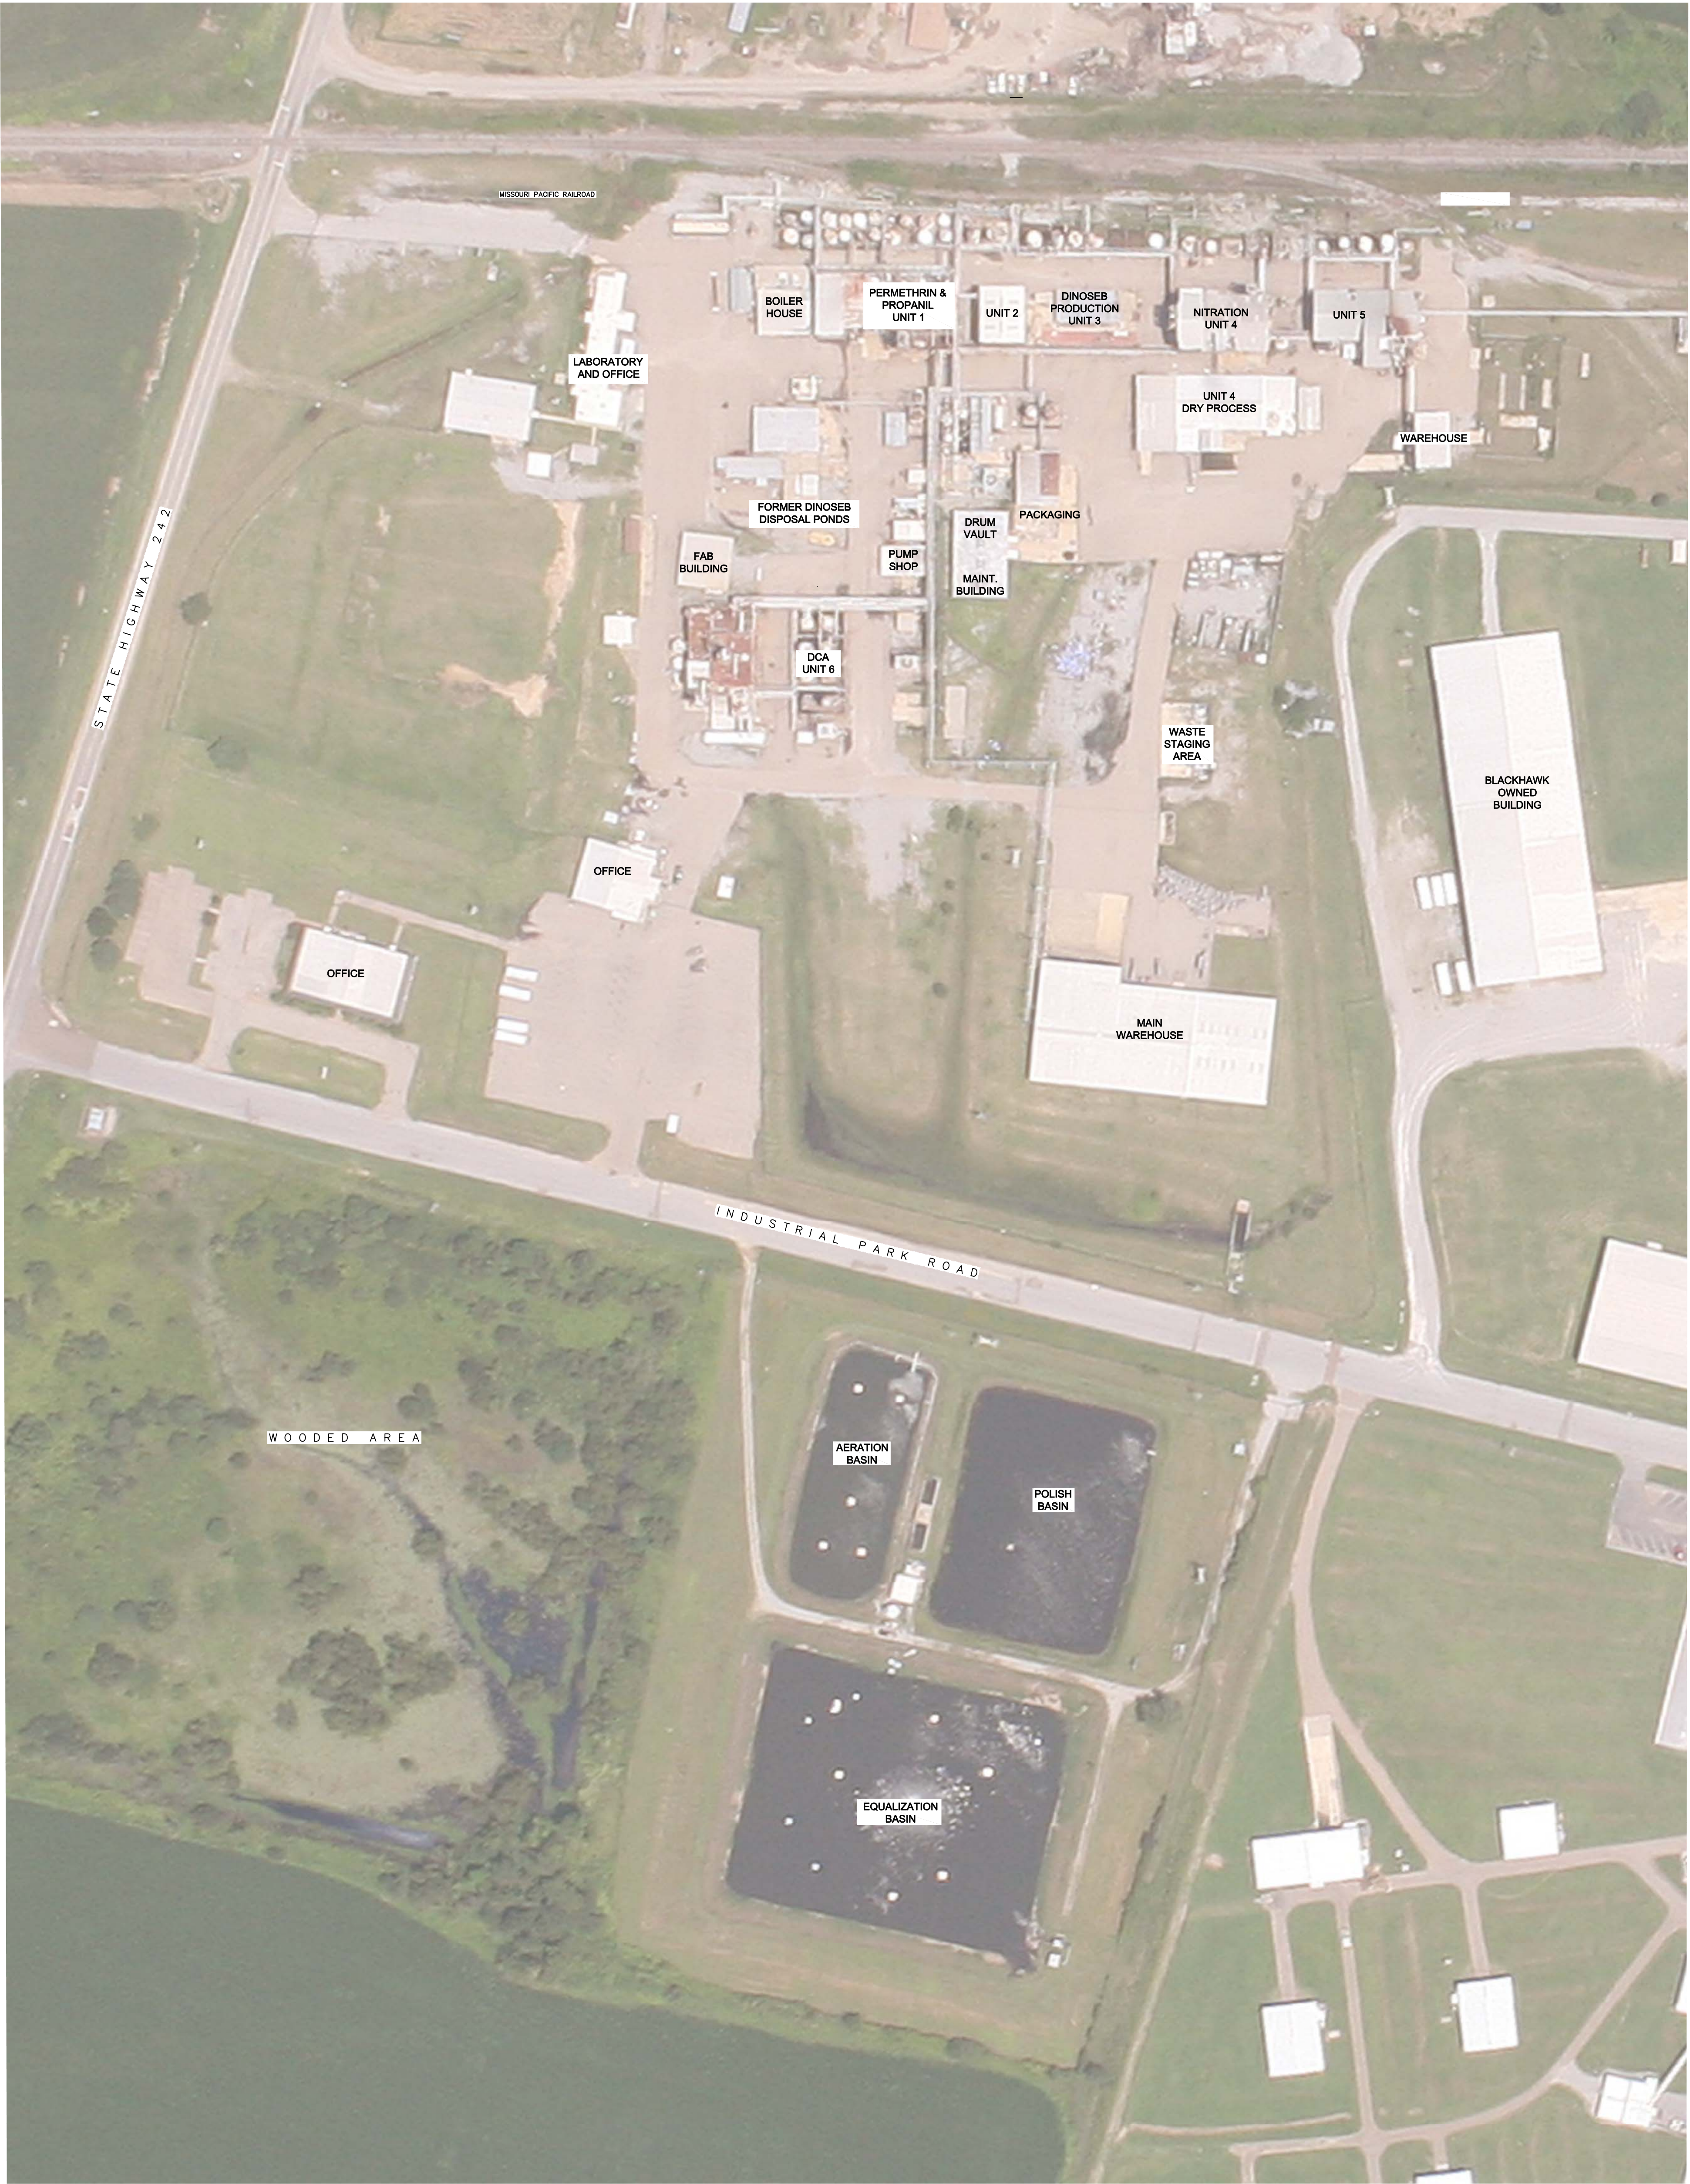
Facility Structure Locations		
Cedar Chemical Helena-West Helena, Arkansas		
Figure 2

- Recommendations for Removal of Site Structures
 - With the exception of the Office buildings and the large Warehouse building (requested by ADEQ to remain in place for potential future use), all aboveground portions of buildings, process units, tank systems, and related site structures at the Facility will be demolished or deconstructed (see **Figure 4**). Unless their removal is required to implement a selected remedy element (for example, excavation, or stabilization), slab foundations or similar at-grade and below-grade portions of these structures could remain in place to be incorporated into the soil cover system. In this event, the foundations and related structures should be inspected prior to their reuse. If any of these foundations or similar structures contain sumps, major failures, or other related breaches in their integrity, these will be permanently sealed as a part of the demolition/deconstruction process. In addition, storm grates, drains, and piping running beneath the demolition and soil cover area will be permanently plugged. To the extent practicable, any portion of the structures that can be readily recycled will be salvaged.

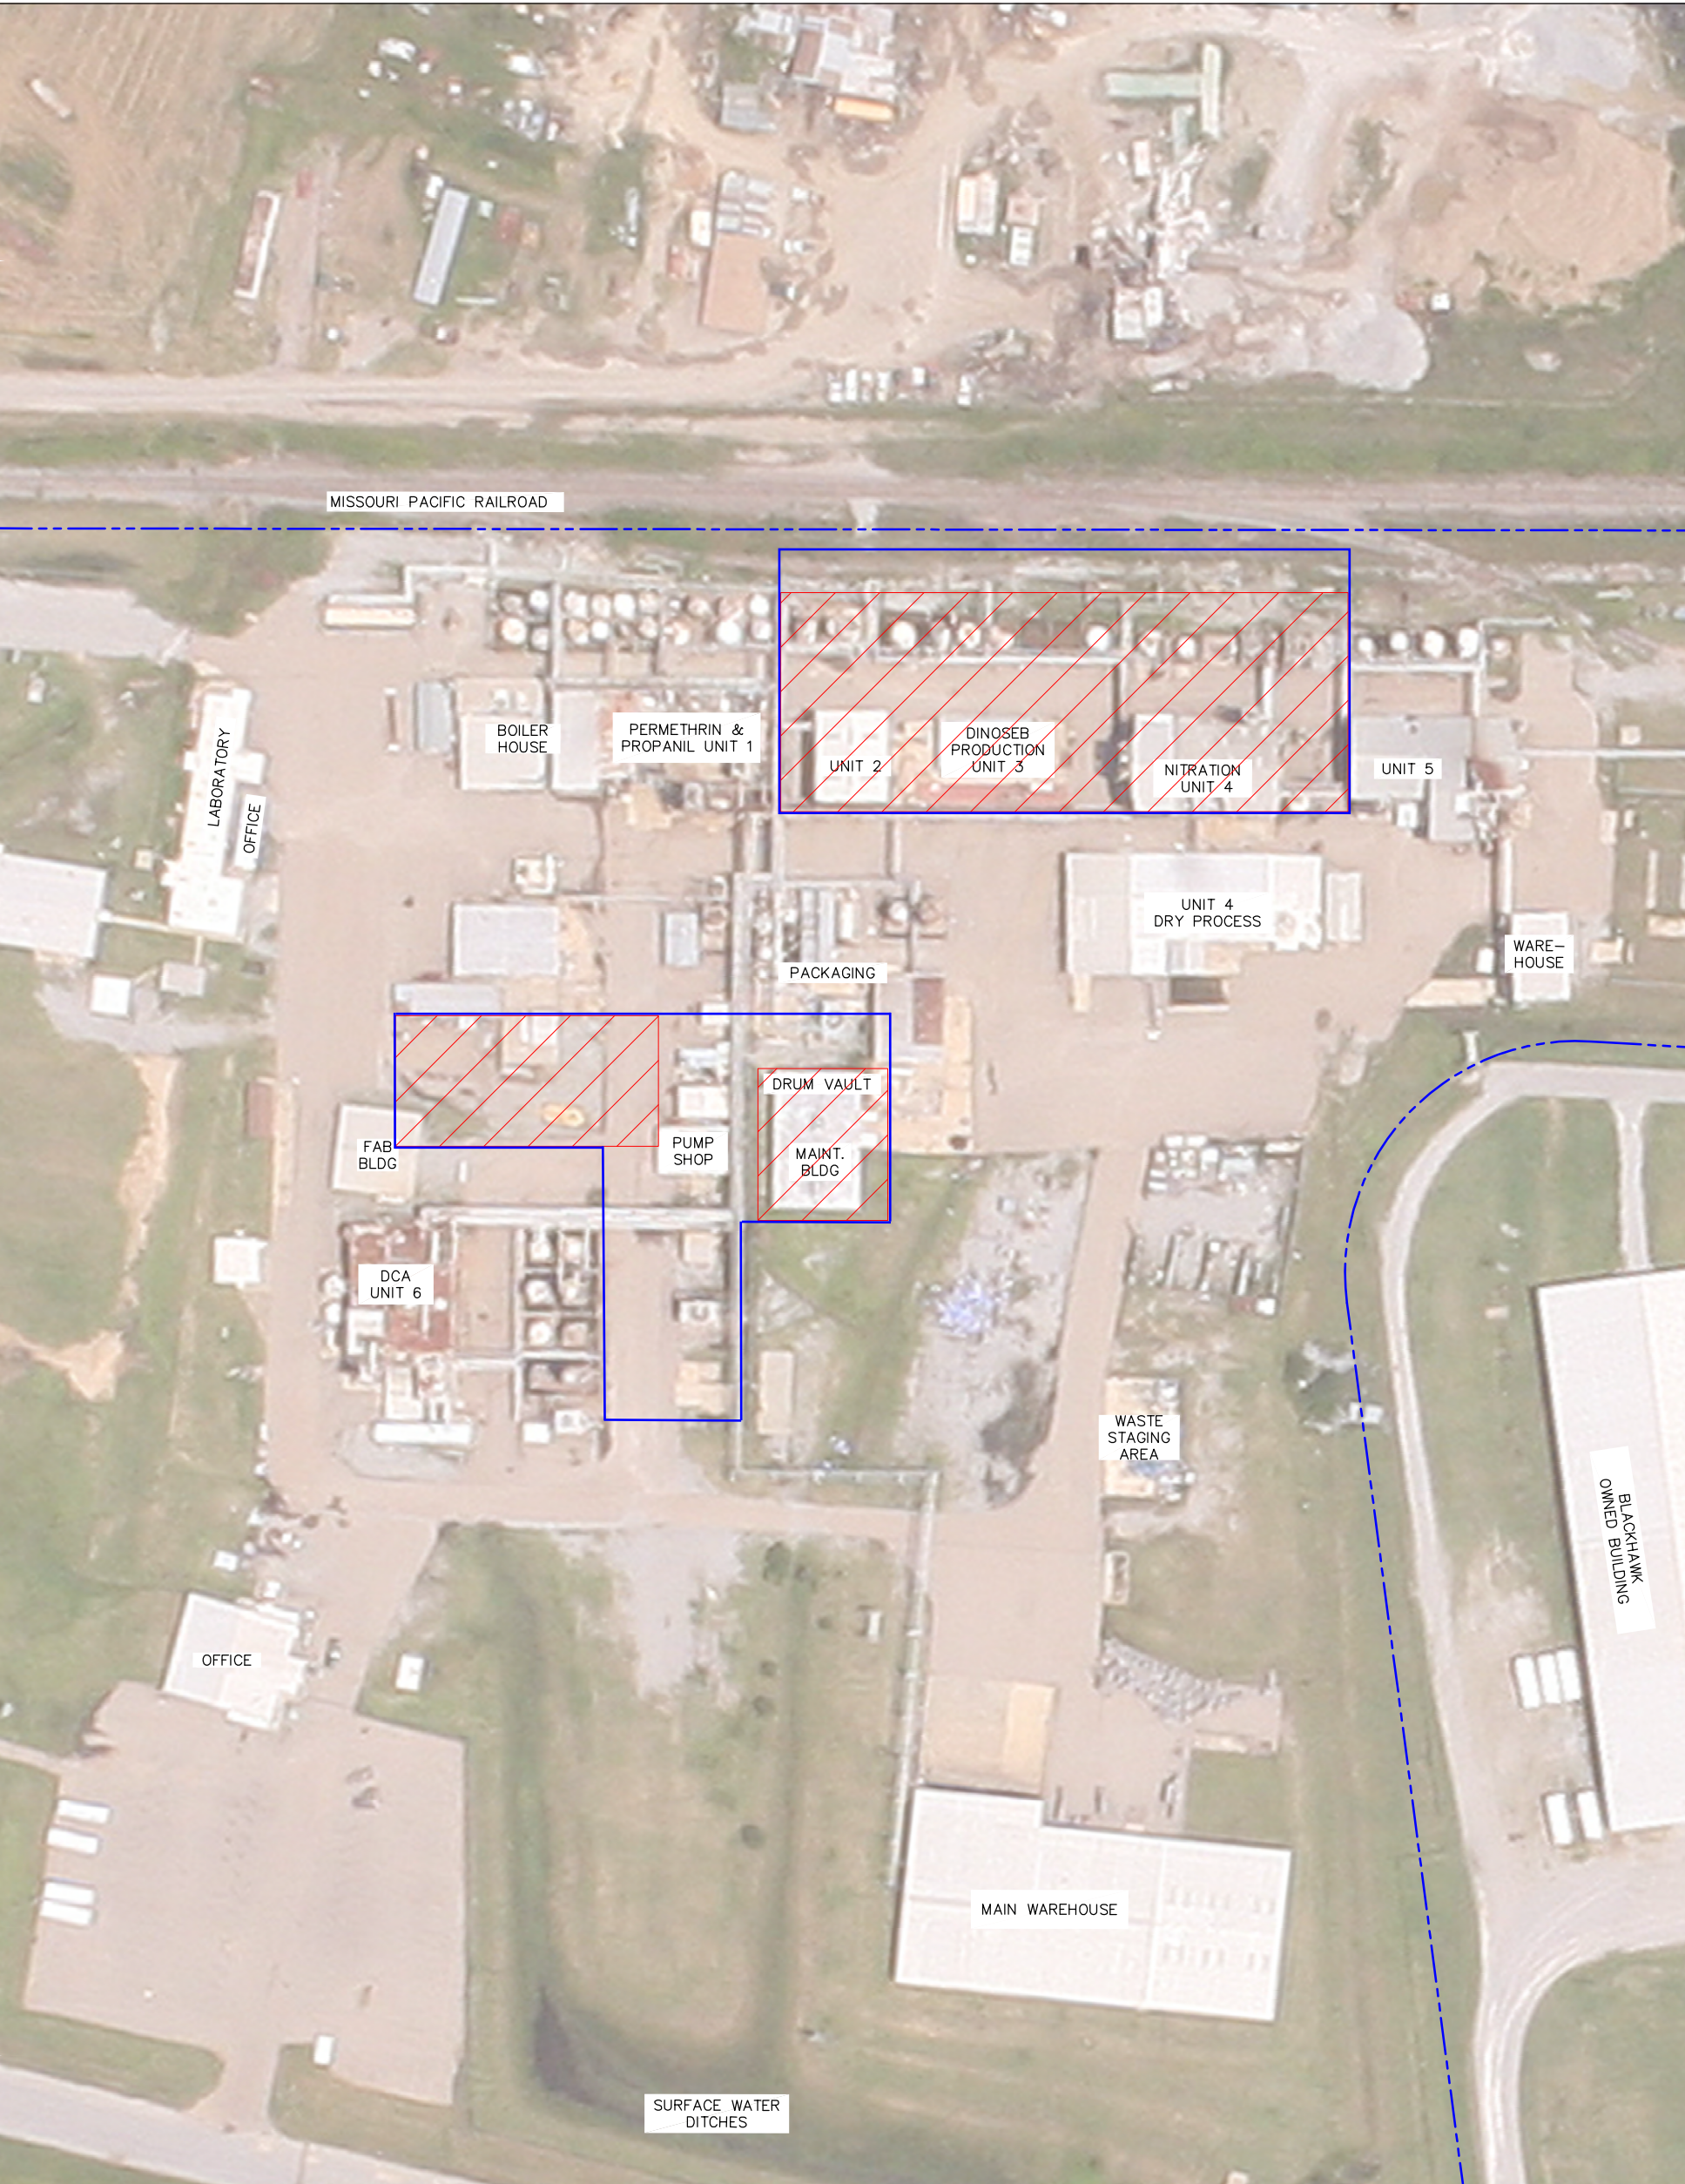
SOIL REMEDY ALTERNATIVES S2b and S2c Focused Approach Cedar Chemical Helena-West Helena, Arkansas		
Figure 5

NOTE: Boundaries, well locations, and remedy elements subject to change based on Remedial Design or other factors.

- Soil Remedy Alternative S2c: In Situ Stabilization, Focused Approach, ADEQ RADD follows the same guidelines as Soil Remedy Alternative S2b: In Situ Stabilization, Focused Approach, FS Figure 8B found in the FS, but expands the remediation area to include significant dinoseb contamination that lies outside of the boundaries proposed in Figure 8B of the FS (see **Figure 5**).
- Soil Remedy Alternative S4c: Soil Vapor Extraction, Focused Approach, ADEQ RADD follows the same guidelines as Soil Remedy Alternative S4b: Soil Vapor Extraction, Focused Approach, FS Figure 10B, but does not include the area encompassing Units 2, 3, and 4 that will be addressed with soil stabilization (see **Figure 6**).
- Perched Zone Groundwater Remedy Alternative P8: Contaminant Mass Removal is a pilot study to test a contaminant mass removal technology for the perched zone groundwater hot spots.

This alternative follows the same guidelines as alternative Soil Remedy Alternative S2b, In Situ Stabilization, Focused Approach, FS Figure 8B, but expands the remediation area to include significant dinoseb contamination that lies outside of the boundaries of Alternative S2b (see **Figure 5** for comparison of these areas). This alternative will address some of the highest concentrations of dinoseb found on-site and will incorporate SWMU-73 into the remedy, in addition to the areas included by Alternative S2b. Therefore, this alternative is more protective of human health and the environment and has good short-term and long-term effectiveness while costing significantly less than the excavation alternatives. This remedial alternative addresses the soil contamination associated with SWMU-69, SWMU-70, SWMU-71, SWMU-72, and SWMU-73. A cost estimate for this alternative is found in **Appendix B**.
